eHelp!

November 2012 • ISSUE 10P

Question: Why Doesn't my Auger Dig Better?

Answer: Because Your Auger is Worn Out!

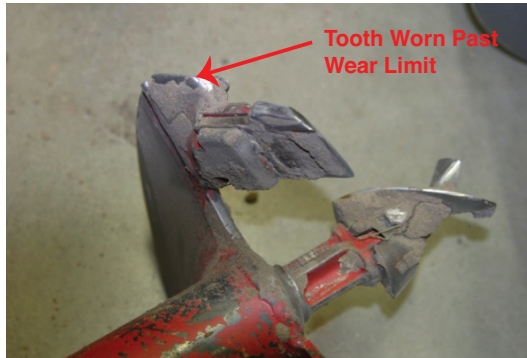
The outside tooth of this 4400-8E3 Earth Auger is severely worn from extended use. There is insufficient material remaining to secure a replacement outside tooth. The auger will now "bind" itself in the hole while digging and is no longer capable of digging an 8 inch diameter hole. The auger was removed from service and scrapped.

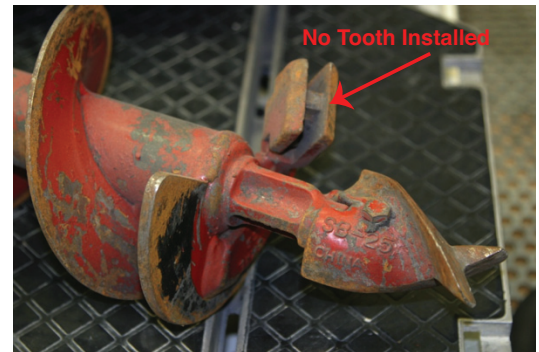
This 4400-6E3 Earth Auger is missing the 35HFC Tooth. Digging performance will be minimal even in soft soil conditions. Want to minimize complaints? Before each use, always check to see the proper blade or teeth and the correct screw bit are installed.

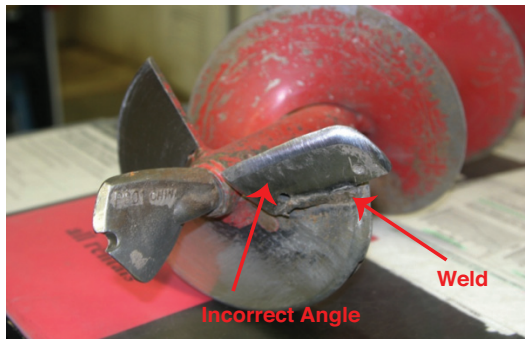
The blade for this 2135-6E Earth Auger was allowed to wear where it became impossible to install the correct replacement blade. For some, unknown reason, a replacement blade for an 8 inch auger was incorrectly welded upside down on the steel plate. The blade angle is also incorrect. The auger was scrapped for performance and safety considerations.

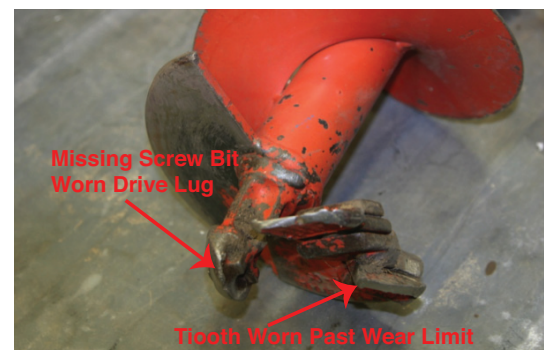
The SB25 Screw Bit from this 4400-8E3 Earth Auger (auger tip) became missing. It was not noticed and never replaced. The drive lug is significantly worn (what remains of it) and will not allow the auger to properly track. This auger was scrapped for performance and safety concerns.
