General
EQUIPMENT COMPANY

Solutions for Equipment Professionals

July 2013 • ISSUE 17P

It's summertime and augers are in high demand. Is it time for some very much needed auger maintenance?

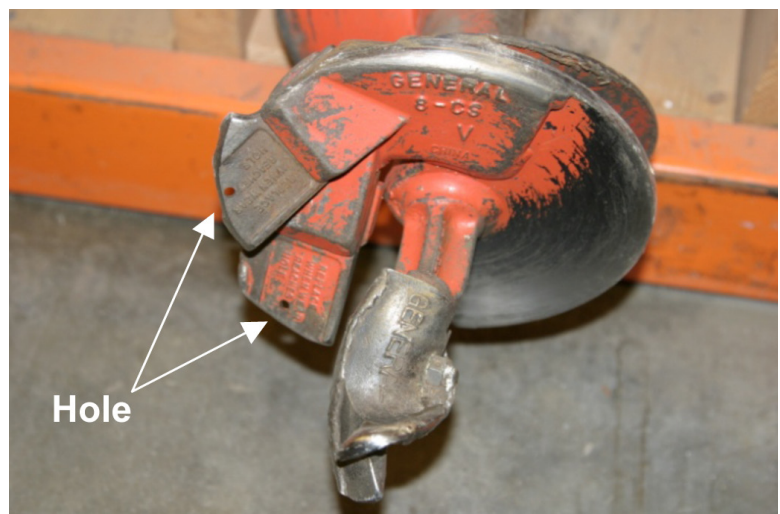
FIGURE 1.

Note the hole provided in the 35HFC Tooth. The hole is a wear indicator. When the tooth wears down to the hole, it is time to replace the tooth! Protect your investment. **Figure 1.**

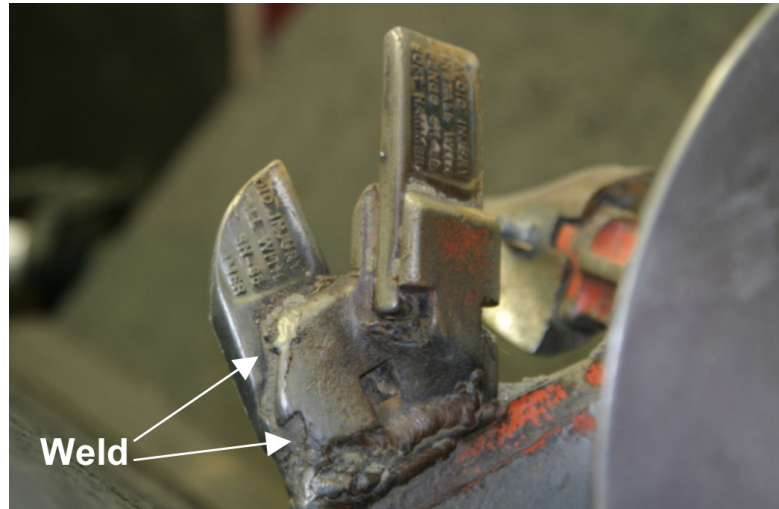
FIGURE 2.

This is what happens when teeth are not replaced as needed. The replacement tooth was then welded to secure it to the bit shank plate. When the tooth further wears, the auger can only be scrapped. Protect your investment! **Figure 2.**

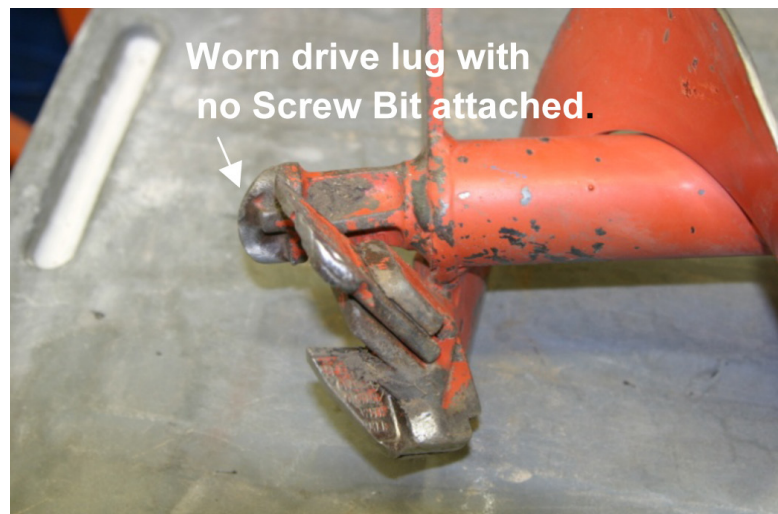
FIGURE 3.

Poor maintenance allowed this auger to be rented without a Screw Bit or tip bolted to the drive lug. Do you have Two Man auger that look like this? If so, they need to be scrapped because of safety and performance considerations. Protect your investment! **Figure 3.**
