November 2013 • ISSUE 18P

Question: What Happens if a General Two Man Hole Digger is Operated Without Oil in the Transmission?

General
EQUIPMENT COMPANY

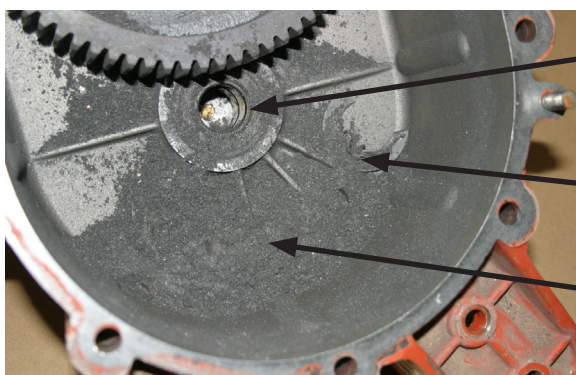
Sealed ball bearings.

Remains of a much worn 200682 Thrust Washer.

Significant accumulation of gear and clutch shoe shavings located in the bottom of the transmission. The powder-type consistency of this material indicates there was no oil added to the transmission.

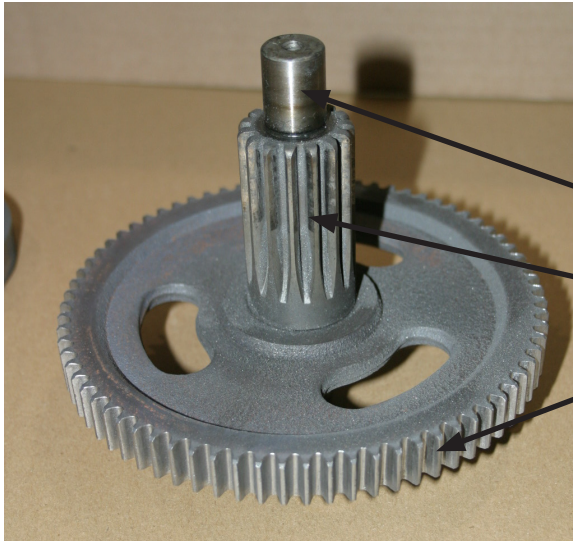
Markings on bearing journal area indicate proper press fit and support by the two ball bearings.

Wear pattern on gear teeth reveals excessive wear and lack of lubrication. Gear teeth are heat treated to extend the service life. Shavings from the worn gear and clutch accumulated in the bottom of the transmission.

This centrifugal clutch has been in continuous use with General hole digging products since 1970. Shoe wear pattern is consistent with normal wear. Hub finish indicates the clutch was not subjected to excessive slippage which would cause the resulting heat to discolor the plating.

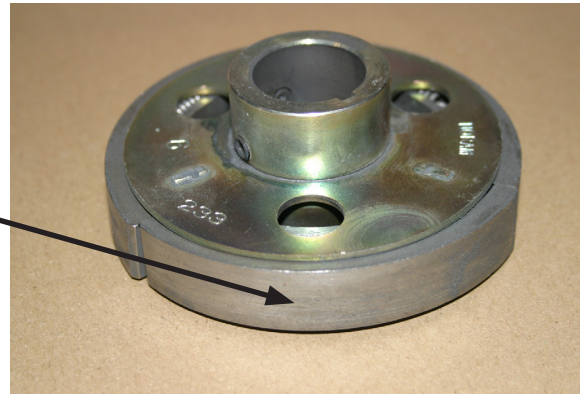
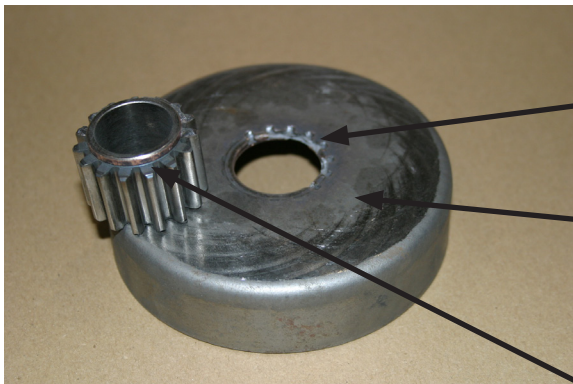
Markings indicate the high temperature brazing process properly bonded the clutch drum and pinion gear.

Marks caused by the separation of the pinion gear from the clutch drum.

Lack of lubrication caused premature pinion gear bearing failure. The bearing totally disintegrated which only happens when insufficient lubrication has occurred.

Before placing any General light construction product in service, always read the appropriate Operator Manual, including the Assembly and Service instructions provided. If you have questions regarding proper oil types and/or weights, or even proper maintenance procedures, please contact our Customer Service Department for assistance.
